Our lowest ever AFR rating

Updated cardinal rules

Learning opportunities

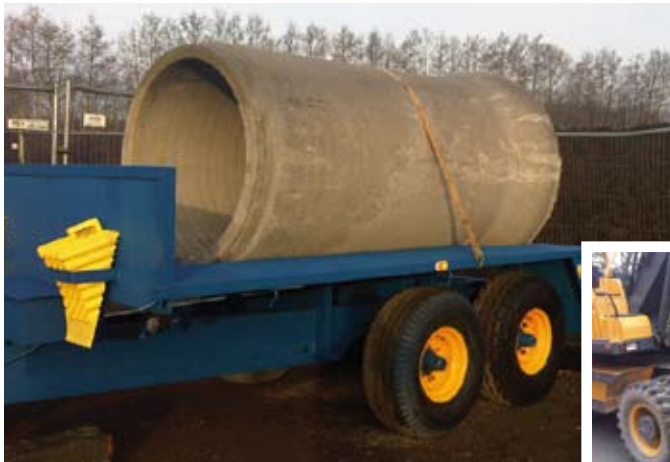
Vacuum pot trailer and stillage frame

In the Eastern region the team have had a trailer modified to accommodate 1200 diameter pipes used for constructing 'pots' in a vacuum sewer system. A pot is effectively a manhole access into the system that assists in generating a vacuum. However, due to their unsymmetrical shape the pots were not easily transportable and therefore a flatbed trailer with an inbuilt trough was designed to increase stability. Consequently transporting these around villages has been made a lot easier and safer.

The pots are augered into the ground by an excavator mounted auger. As with the pots, moving the auger around village streets when attached to the excavator dipper arm is awkward for the operator and potentially dangerous for other road users and pedestrians. The stillage holds both the auger and the drive unit neatly side by side in a frame that is simply hooked over the top of the stabilising blade fitted to wheeled excavators.

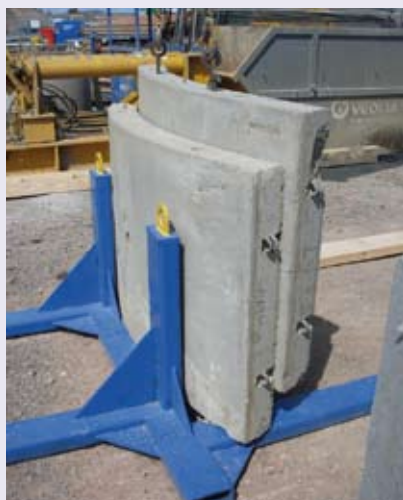
Segment storage

Following the RIDDOR major injury in April 2009 which resulted in an operative's foot being trapped and fractured by a falling shaft segment, a permanent solution to prevent re-occurrence has been finalised. The introduction of the segment storage frame complete with 'L' Brackets (as pictured) will enable segments to be stored in a safe manner, now and in the future. The use of the equipment is a mandatory requirement for all sites requiring segment storage from this point forward, hence any sites procuring segments will be required to hire the equipment directly from BCS. The equipment will be delivered with instructions for safe storage for shaft segments,

providing valuable instructions on their safe use and required storage area requirements to ensure future safe storage.

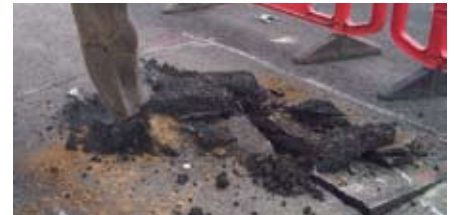
Modified ripping tyne

Normally used to break and rip out blacktop paving, the ripping tyne has simply been modified with a mounting plate that enables the tyne to be connected to a quick hitch. The work is done in the same way as a breaker i.e. the area to be removed is marked out, services identified and the road cut out. Then, instead of breaking up with a breaker attachment, the blacktop is ripped up using the tyne. This significantly reduces noise typically associated with a traditional breaker thereby reducing a major risk from a H&S and an environmental nuisance aspect. It also removes the secondary hazard of flying chippings. However, the risk associated with service strikes remains equivalent with breaking and therefore requires the same level of investigation and care.

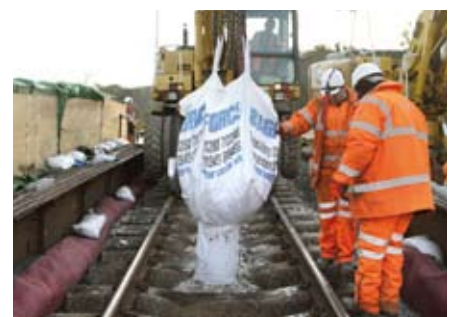
Bags with chimneys

On Barhale rail schemes at Truck Road and St Agnes Railway bridges the rail business has used 1 tonne bags with chimneys to prevent all manual handling issues. In addition this innovative modification allows the accurate placement of stone.

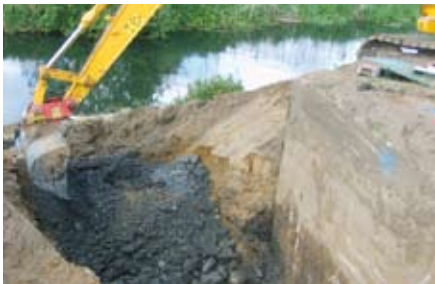
A small amount of hydrocarbon leaked from a river bank into a local watercourse. The source of the leak was a partially unscrewed drain cap on a 6" pump which had been unnoticed during a re-siting of a pump. Contaminated soil was removed from site to eliminate further pollution.

Digging out contaminated soil and inserting clay

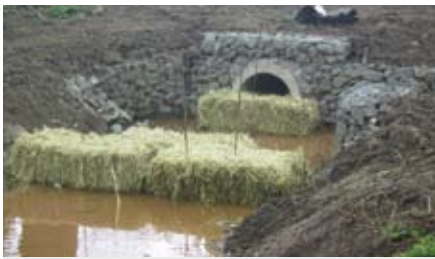
On a surface water drainage scheme some material built up behind shuttering. When this was removed a large volume of water and silt flowed to a new outfall and discharged into a stream, causing heavy staining. The discharge was spotted immediately, operations stopped and straw bales were placed at the outfall to stem the flow.

Straw bales to restrict flow from outfall

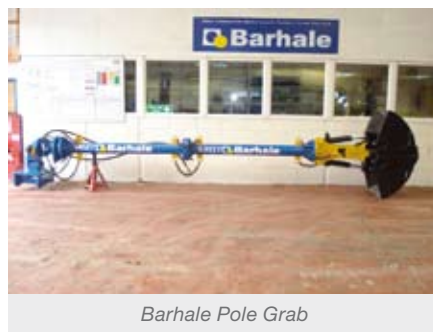
Barhale Pole Grab

Each of the incidents highlighted that wrong bolts were used to connect the pole grab flanges, and no 'fail to safe' mechanism existed to prevent sections of the grab falling from height after failure. Improvements now include high tensile steel black engineering bolts grade 10.9 which is a minimum requirement for all internal and externally hired pole grabs and 2 safety chains at each pole flange joint.

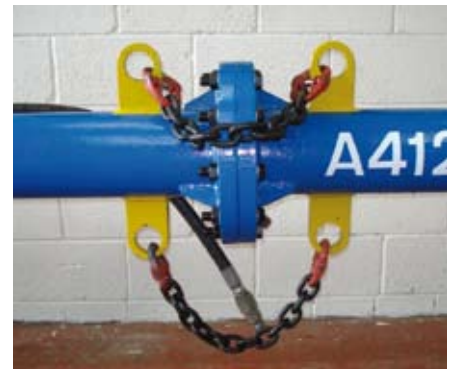
Pole Grab bolts and safety chains

We are in the process of communicating our standards to suppliers ensuring they comply with our requirements. In addition to the improvements made to the equipment, Operators will have to complete bolt security checks three times per day.
