Foreword

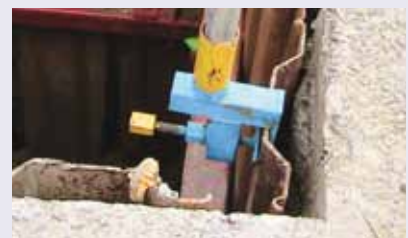
Scaffold mounting clamps

BCS have manufactured clamps that help provide a solution for mounting scaffold pole hand rails onto sheet piles. The clamps are versatile in that not only can they be used on sheet piles that have been installed to ground level, they can also be quickly removed at night to allow the excavation to be covered with a road plate during out of working hours.

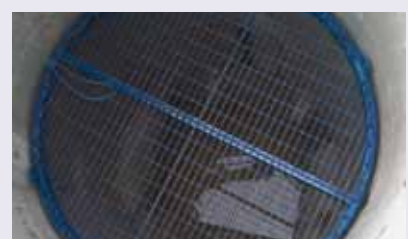
Shaft working platform

The Eastern region recently commissioned BCS to manufacture shaft working platforms for use on the Elm first time sewerage scheme. The platforms were devised initially to support the TT micro tunnelling rig for lateral installations. Traditionally the rigs had to be jacked up or supported on scaffolding from the bottom of manholes. However, the steel mesh-floor platform is much easier to install as it utilises easy to fix L brackets as support. The site team also found an alternative use for the 2m diameter versions as temporary shaft covers.

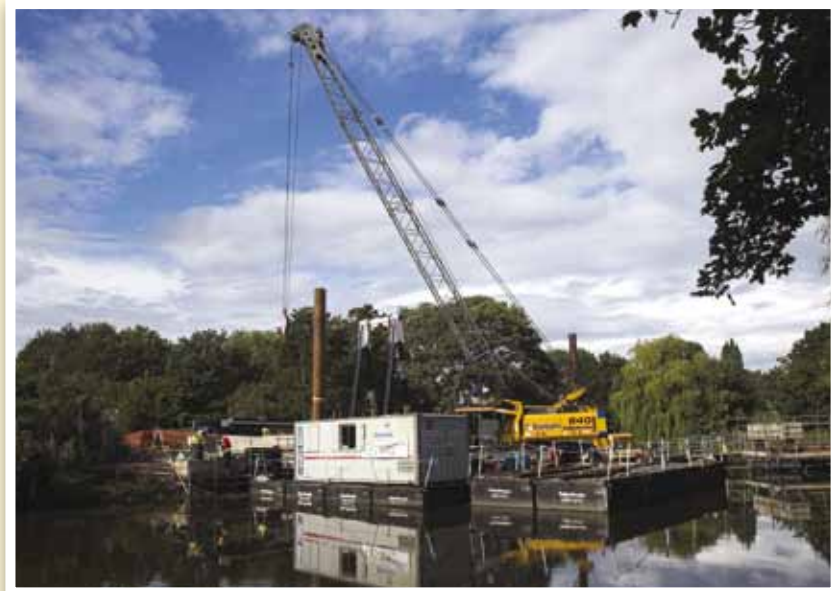
Bridge replacement

The Northern Stream project at Riversdale in Northwich, Cheshire, required replacement of an existing timber swing bridge across the River Weaver and comprised the installation of steel tubular piles for abutments and fenders, construction of concrete base and foundations for the slewing mechanism along with home and far bank landing structures. The project was challenging, for example, there was no vehicle access to the site, the only means of bringing in plant, equipment, materials and the new bridge components was down the river on pontoons. The site required planning and management of nesting Sparrow Hawks immediately adjacent the site, installation of an otter holt and provision of bat boxes that required working in close liaison with Natural England and Cheshire West Council (Client).

The principal risk factor for both H&S and the Environment was working close to water. These aspects required careful management with rigorous controls at all times on items such as refuelling, use and storage of fuels and substances. A safety boat was needed and life jackets were mandatory PPE. Lifting operations were carried out with a crane mounted on a pontoon. The site used a solar powered welfare unit to reduce the need to refuel over water.

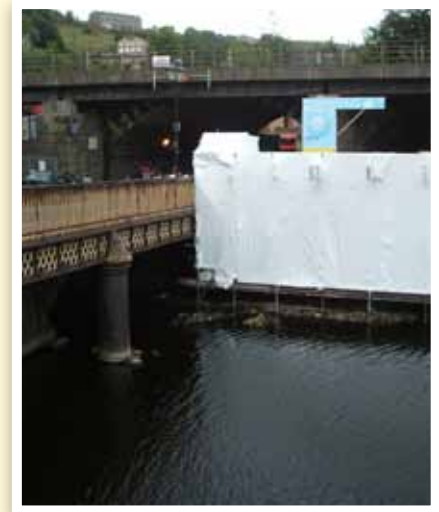
Minimising nuisance and pollution risk during bridge refurbishment

Part of the County Bridge contract involved refurbishment to the existing bridge structure. A cantilever scaffold was erected from the pavement over the existing parapet and down the outside face of the existing structure to gain access to the external bridge faces. A cantilever scaffold method was adopted to satisfy the Environment Agency flood defence consent which required the river flow not to be restricted by our works. The scaffolding was fully encapsulated using Enviwrap sheeting to the external faces and visqueen to the underside of the scaffold platform. This allowed wet and

dry grit blasting and painting of the exposed steel surface to take place, fully containing all dust and waste. The existing paintwork was found to have a high lead content and required full containment so as not to pollute the river with lead contaminated shot. The containment also minimised dust pollution and nuisance to the public. The contaminated dust and waste was then removed using a large vacuum and skip system and sent to a registered waste facility for appropriate management. For more details contact Gary Wilde, Contracts Manager on 01925 821590.

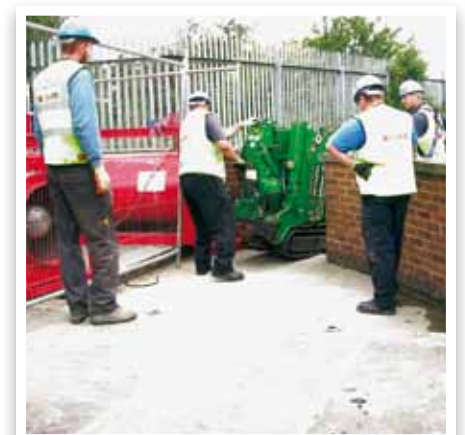
Spider crane

This intimidating looking device is a spider crane, which was used on our Staines tunnel inspection contract. Although the main access to shafts and tunnels was by stair wells, and shaft ladders, the crane was used with a man rider in the event an evacuation was needed. The crane is propelled by a self contained track vehicle and has folding stabilisers which are deployed during use. Because of its small size it is particularly useful for use in constricted areas. As can be seen in the photo we did not have to demolish a wall to get the crane into position.

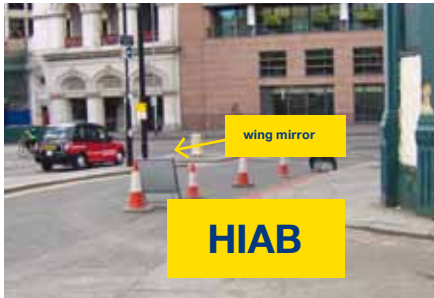
Significant Near Miss Lifting a 9T Excavator with a Hiab

When lifting an excavator with a Hiab using lifting chains attached to the chassis, the wing mirror from the excavator was snapped off and flew across a busy road. A lifting beam should have been used to lift the excavator. In addition, the possibility of underground services situated beneath the Hiab outriggers had not been fully assessed.

- Always make sure that all lifts (including Hiab's) are sufficiently planned and follow the lifting operations procedure
- At lift planning stage always refer specifically to the manufacturer's handbook for the lifting points and correct method of lifting the excavator
- The lifting activity could have been avoided by selecting a vehicle with a hydraulic tail lift

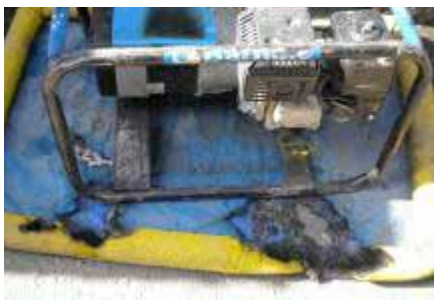
Operative receives burns whilst refuelling a petrol generator

An operative received significant burns to his right forearm whilst refuelling a 3.5 kva generator. Both the equipment and individual caught fire during this particular incident.

The generator was used to power task lighting and had been running for a significant period.

Precautions to prevent the possibilities of fire when refuelling petrol driven equipment are:

- Fire risk assessments must cover refuelling operations.
- Always ensure generators and equipment are positioned to allow refuelling operations in well ventilated areas.
- When refuelling, always switch off the equipment first and allow the unit to cool down.
- Always use a petrol can with nozzle or an appropriate funnel when refuelling.
- Do not overfill fuel tanks, always allow for fuel expansion.
- Remember to always ensure equipment is placed on a drip tray or plant nappy and clear any fuel spills.

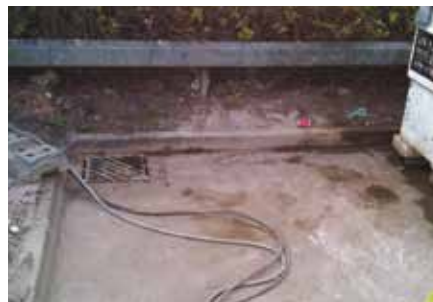
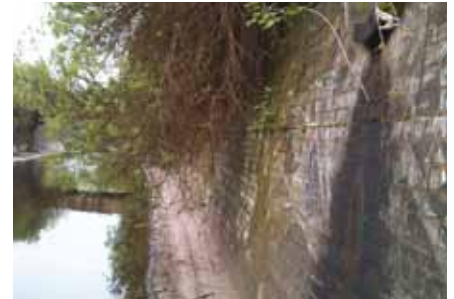
Diesel tank fuel spill

Following the decommissioning of a generator a residual amount of diesel needed to be moved from a fuel tank supplying the generator to the main site fuel tank. After the pumping out the diesel, using a hand pump, the hose was not disconnected but left on top of the tank. Residual diesel from the hose subsequently leaked and entered a nearby storm drain, which was less than 5 metres from an outlet into an adjacent river. Fortunately it was found that diesel had stained the brickwork adjacent to the river but had not entered the river. The storm drain was subsequently blocked using a drain plug and an absorbent boom was used as a precaution.

The site team had previously closed the drain during site set up and had assessed that no pollution pathway to the river was available. However, 3 weeks before the incident, the storm drain was reopened without the fuel storage area being moved or protection measures being put in place.

- Fuel and chemical storage areas should be located at least 10 metres from any surface water features such as drains, ditches, rivers or open ground.
- When setting up site compounds and fuel storage, pollution risks need to be identified and assessed with controls such as location, bunding, drip trays, plant nappies and spill kits used to prevent pollution.
- Changes in site set up or other arrangements should be reassessed to ensure new pollution pathways are controlled.
- Information must be displayed on a site emergency plan. This helps visualise risks and identify controls.
