Roundtree and Greenford Road

Client:	Network Rail
Location:	London Borough of Brent
Value:	£1m
Duration:	5 Months

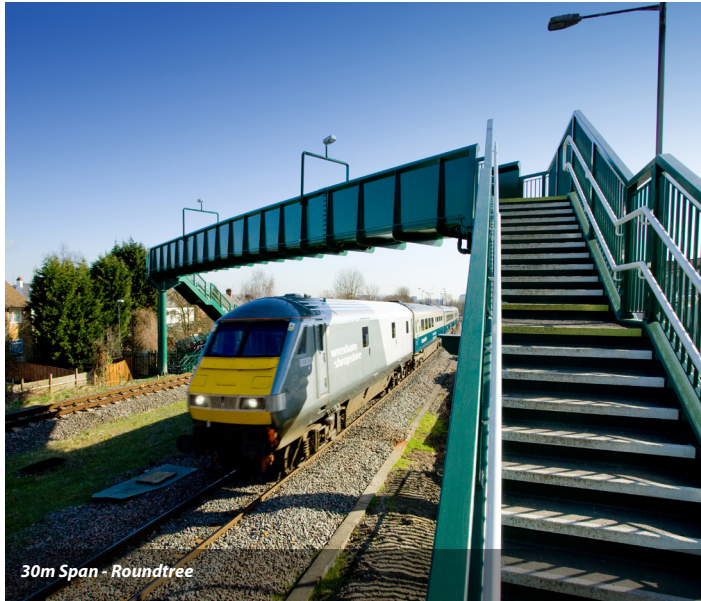
30m Span - Roundtree

The works at Roundtree Road comprised of the removal of the existing footbridge and replacing it with a new all steel 30m span footbridge.

Demolition and removal of the existing footbridge and foundations were undertaken during a 24 hour track possession allowing the new bored piled foundations and pile caps to be installed. The designed depth of concrete pile caps necessitated the use of temporary sheet piles in the embankments during excavation works to maintain the integrity of the rail tracks. A 400 tonne mobile crane situated within the adjacent cul-de-sac was used to undertake the installation of the bridge sections in weekend track possession.

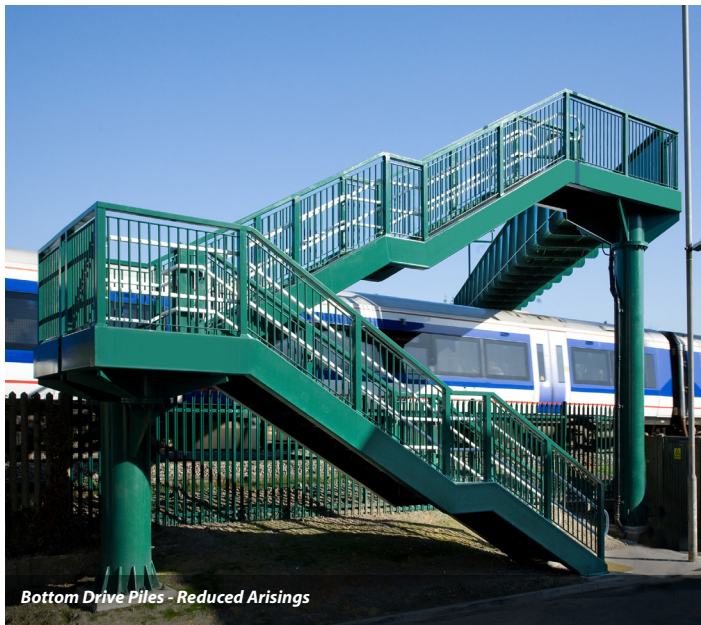
Bottom Drive Piles - Reduced Arisings

- Barhale proposed an alternative form of bottom driven piling, and retaining arisings within the wide cess. This minimised the need for removing materials to landfill and reduced our carbon footprint and cost
- Minimised disruption to local residents by working at midday on a Sunday, when site staff were least likely to disrupt local residents.
- The large span was transported to site via a restricted residential access road using steerable trailers, this required careful route planning and liaison with the local highways authority and affected residents.
- The steel bridge that was replaced on Roundtree Road was recycled and spoil was deposited on the embankments.
