Thames Valley Reservoir Refurbishment

Client:	Thames Water
Location:	Various locations
Value:	£2.2m
Duration:	22 Months

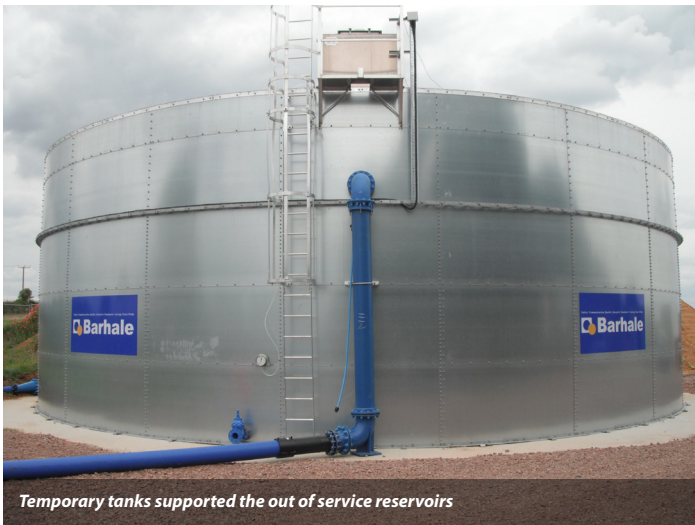
Temporary tanks supported the out of service reservoirs

The reservoirs are located in isolated areas and are classed as island supplies within the network. It was therefore necessary to construct temporary tanks alongside the existing reservoirs with a capacity of 1 million litres to enable the reservoirs to be taken out of service, whilst maintaining uninterrupted supply to the network. The temporary tanks had to mimic each individual existing reservoir from control levels through to fully integrated statutory sampling systems. The stakeholder team worked closely with land agents to obtain agreements from landowners and Thames Water Operational Staff to enable construction of the tanks alongside the existing reservoirs.

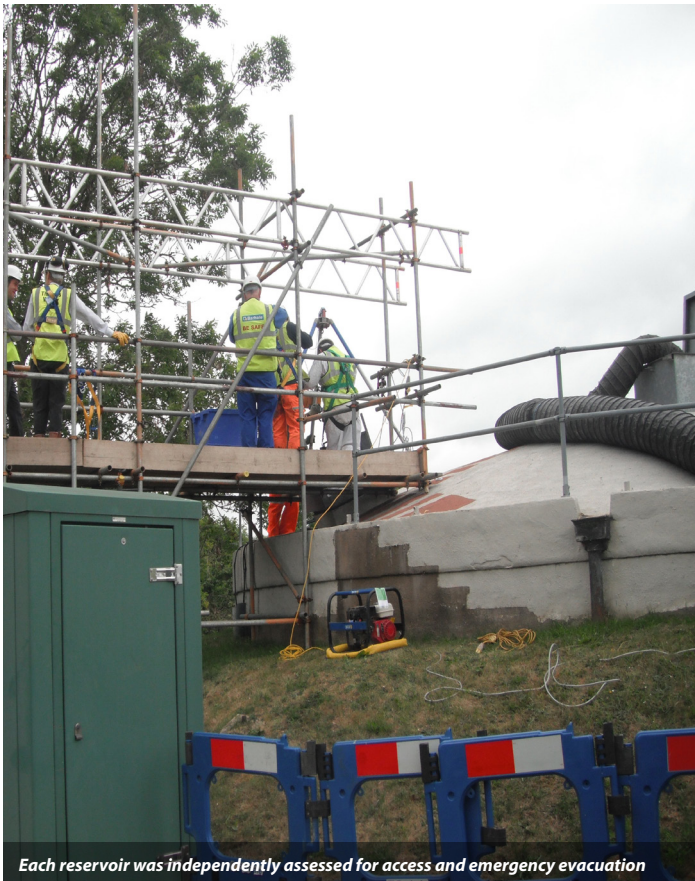
Each reservoir was independently assessed for access and emergency evacuation

Access to each reservoir was restricted due to a single hatch point entry, which is located on the lower section of the domed roof. The domed roof is a hazardous area due to the shallow thickness of the concrete structure. To enable a full confined space entry for an inspection and specialised repair team each reservoir was individually assessed regarding access and emergency evacuation. Large independent cantilevered scaffolding access platforms and towers were installed prior to the works to mitigate the entry risk that each reservoir posed.
