Haddenham Booster Station

Client:	Anglian Water
Location:	Haddenham, Cambridgeshire
Value:	£510k
Duration:	8 weeks

In Brief...

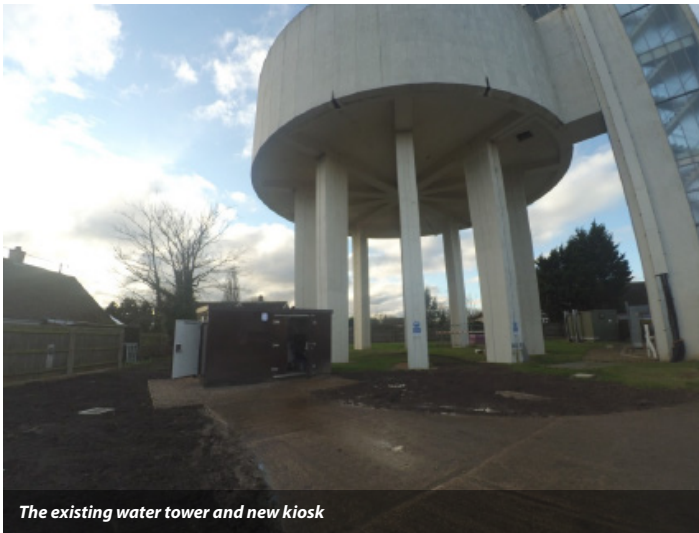
The existing water tower and new kiosk

The booster station was installed before the connecting pipework due to the fact that its placement was limited to one area. This was more time efficient than completing the pipework first. The team cleared the required amount of earth before laying a type 1 base. This was then topped with Bodpave, a low carbon, environmentally friendly alternative to the usual kiosk base. Due to the kiosk design, it could then be placed and installed quickly and efficiently.

The kiosk was a glass reinforced plastic (GRP) unit which arrived at site fully fitted with the two pumps and their associated electrical equipment. It had been pre-planned by the team to sit directly on top of the pre-existing manifolds. A smart pump controller, which allows the network optimisation team to adjust settings remotely and monitor pressures, was also installed. This required an electric cable for the GRP unit to be installed on the site.

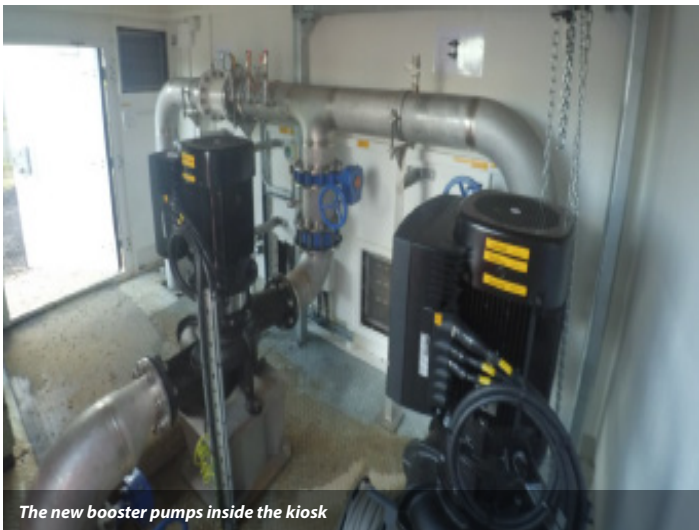
The new booster pumps inside the kiosk
