New Cumnock Flood Protection

Client:	East Ayrshire Council
Location:	Leggate, New Cumnock, East Ayrshire
Value:	£770k
Duration:	18 weeks

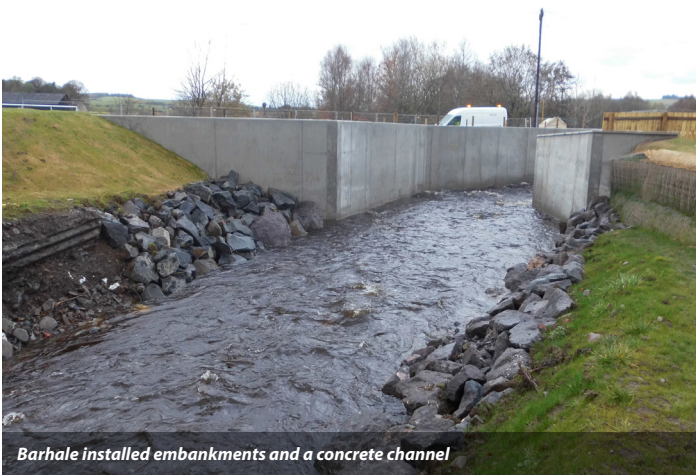
Barhale installed embankments and a concrete channel

Barhale were engaged as Principle Contractor to install water retaining earthwork flood embankments and to install in situ reinforced concrete walls within Connel Burn. The works consisted of concrete walls, embankments, bank erosion protection and side overspill upstream of Leggate to reduce flow into the Connel Burn.

Having diverted the flow, trimming was carried out within the streambed to remove stones and debris and to level the surface for the installation of the cast in situ concrete. The steel reinforced concrete walls and base were then installed within the burn over a length of 50m. This area is where Connel Burn runs in close proximity to residential homes. The concrete section formed a squared U shape to minimise potential for overspill once the burn was reinstated. To provide further flood protection the embankments were raised by 1m.

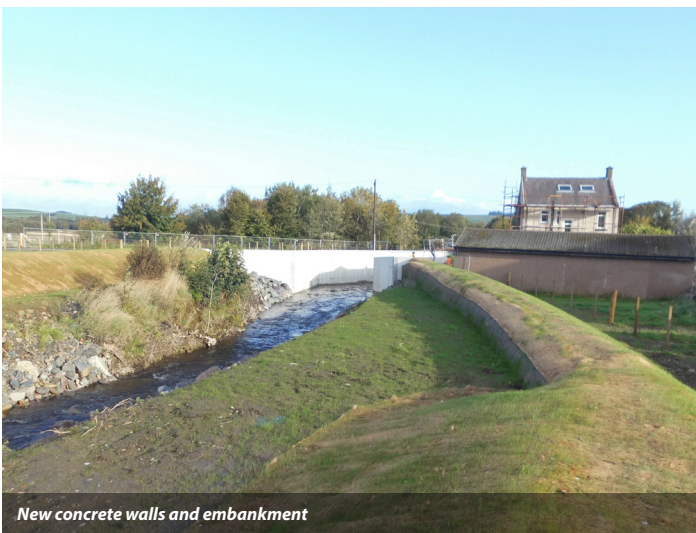
New concrete walls and embankment
