Palace Road – Trunk Mains Rehabilitation

Client: eight2O

In Brief...

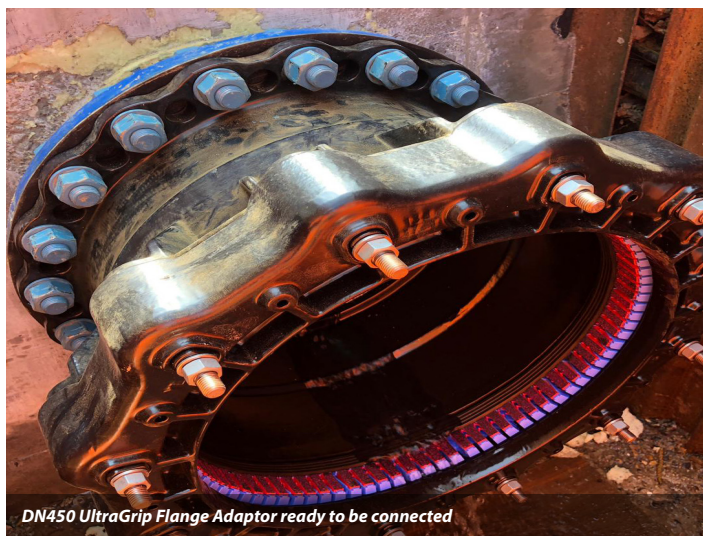
DN450 UltraGrip Flange Adaptor ready to be connected

- Connect the new trunk main to an existing DN450 Ductile Iron with a thrust restrain block
- 7" connection back into an existing 7" Cast Iron main, using Ductile Iron fittings and PE pipe welded through electrofusion, with a thrust restrain block
- 12" connection of DN300 Ductile Iron with end restraint flange adaptors and bolted pipework, back into trunk main with a thrust restrain block
- Connect new trunk main to existing 18" Cast Iron trunk main with a thrust restrain block

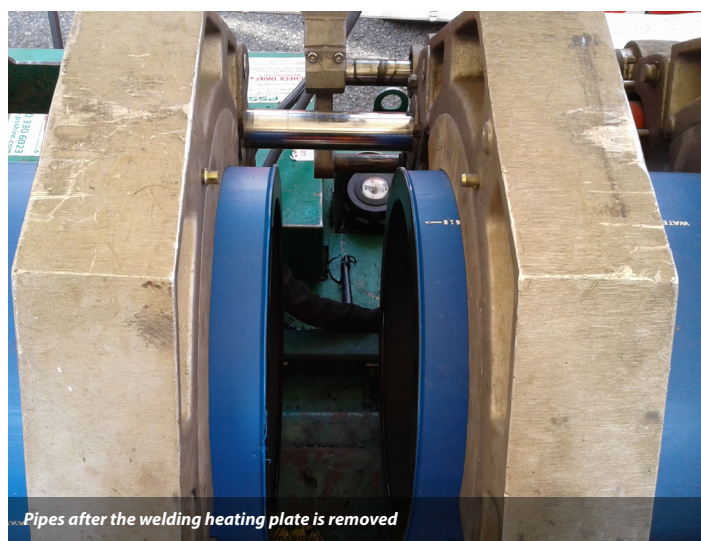
Pipes after the welding heating plate is removed

The team then slip lined the main using 355mm OD SDR 17 PE pipe. The 6m long segments were joined through butt welding. The welded pipe was then pulled through the host main using a mobile winch block, with the winch and the cable assembly set up at the end of the installation in the reception pit, opposite to the pipe staging area in the launch pit. The cable was fed up the existing main to connect to a pull head on the front end of the new pipeline. The pipe was then pulled back through the existing main by the winch.
