# Brentford Waterside Sewer Diversion

<b>Client:</b>	Ballymore Group
<b>Location:</b>	Brentford, West London
<b>Value:</b>	£560k
<b>Duration:</b>	3 Months

Barhale were required to install a new sewer system to facilitate the construction of a mixed use residential and retail development, on a 4.79 hectare brown field site in Brentford, west London.

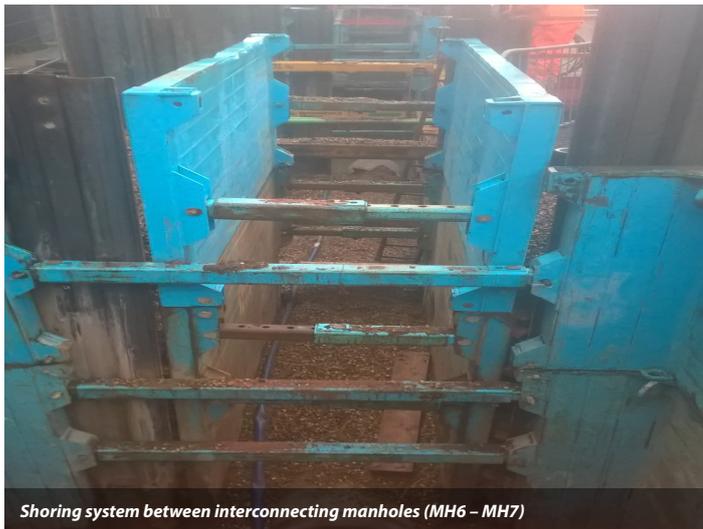
Shoring system between interconnecting manholes (MH6 – MH7)

All works were undertaken via open cut techniques. The pipeline was installed at depths of between 3.5 – 4.5m throughout the site, using a combination of methods, including:

- Drag boxes
- Trench boxes
- Trench sheets and frames

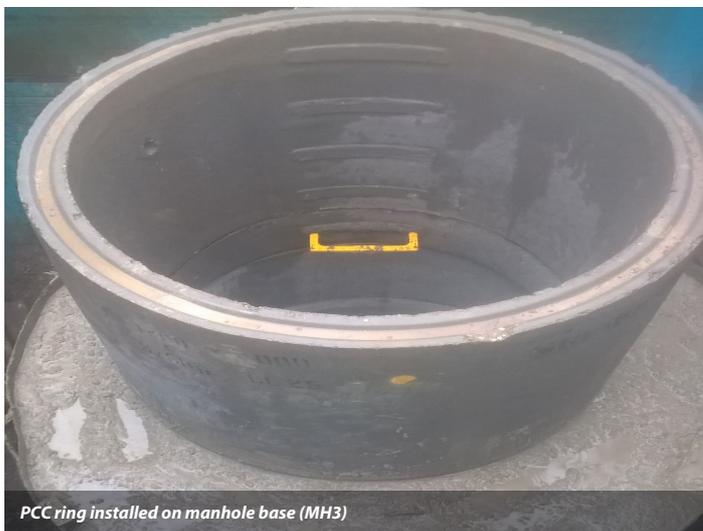
PCC ring installed on manhole base (MH3)

Barhale's works involved the installation of 190m of new 600mm diameter concrete pipeline, along with 6no 1500mm diameter manholes along the run. This will enable flows from the new development to tie into the existing Thames Water network.

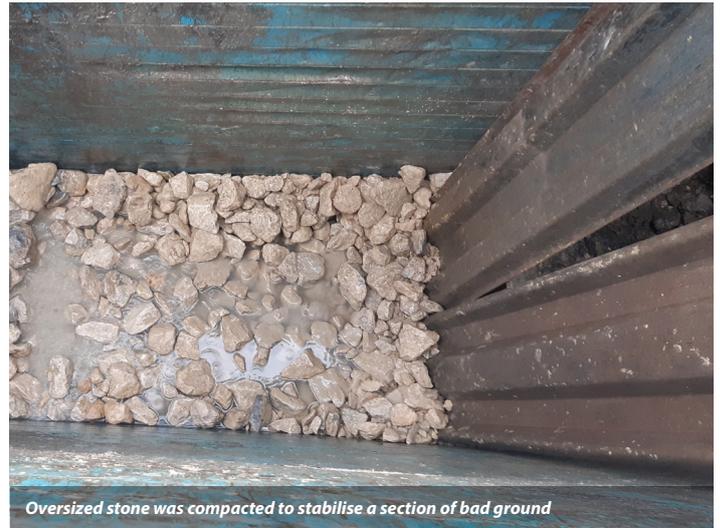
*Oversized stone was compacted to stabilise a section of bad ground*

During the latter stages of the project, the team encountered a section of Marine Silt ground formation. This very soft ground was not suitable to support the new pipeline without additional treatment. In fact the ground was so soft that during excavation, one of the Barhale operatives was able to fully submerge his shovel into the ground with minimal force.

The Delivery Team consulted Barhale's Engineering Manager to discuss solutions. The installation of de-watering well points was first mooted, however there was concern that this may extract fines from the ground, causing settlement which could inadvertently damage the foundations of a nearby road bridge.

After a period of investigation, the team opted to trial the use of rock armour stone to provide a solid bed upon which to lay the pipes. This method involved removing as much of the bad ground as possible through excavation, whilst simultaneously pumping any excess water. Large stones (100 – 300mm) were then placed in the trench and compacted using a 35t excavator. This method proved successful in stabilising the bad ground, enabling the team to continue with the sewer run. Furthermore, this method removed the risk of damage to the adjacent bridge foundations, did not cause an unforeseen delay in the programme and was more cost effective than a dewatering alternative.

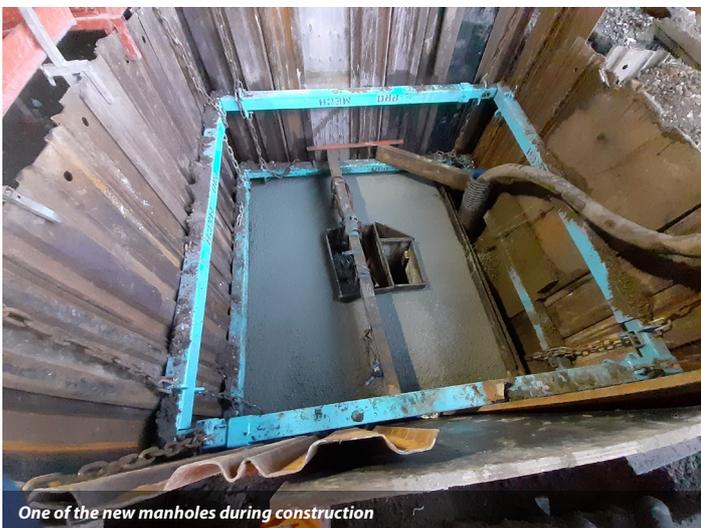
*One of the new manholes during construction*

One of the most challenging elements of work involved the construction of a 3.5m deep manhole underneath an existing road bridge; which had just 3.9m clearance. To ensure the team did not come into contact with the bridge during the manhole construction, a specialised excavator was procured with both a slew restrictor and a height limiter. Construction of the manhole, which was facilitated via a sheeted cofferdam design, was undertaken under the control of a designated Banksman at all times.
