Warwick Tunnel Inspections

Client: eight₂O (SMB JV)

Location: Coppermills, Walthamstow

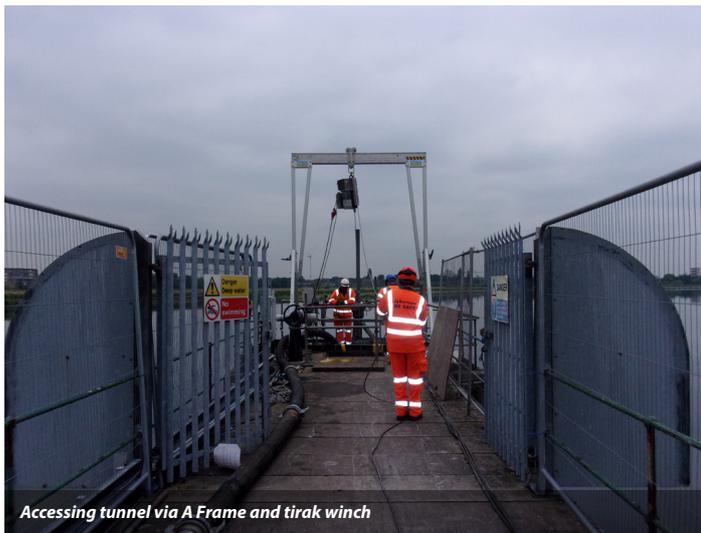
Accessing tunnel via A Frame and tirak winch

The scope of work covered 4 tunnels of which significant sections had been built in the 1800s. The tunnels were accessed via 5no shafts (3m ID, and depths ranging from 16 to 25m), which were located inside the reservoirs. The reservoirs themselves are situated on land that is open to public access via the Wetlands project. In total, the team carried out work on over 750m of tunnels (ID ranging from 1200mm to 2550mm).

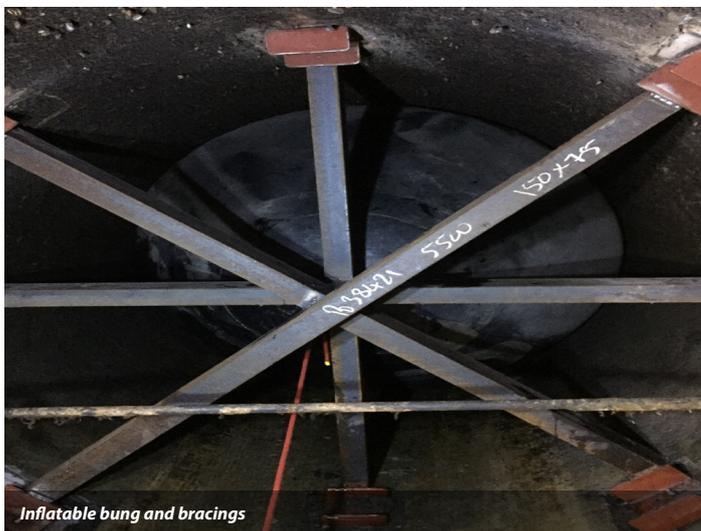
Inflatable bung and bracings

In order to double-isolate a valve that was particularly difficult to access, the Barhale team installed a 2.2m diameter inflatable bung. This was further reinforced with 4 no. 150mm mild steel "C Channel" beams, which were fitted into suitable support brackets. The latter were welded by divers to the inside of the tunnel, and will remain there for future use after the beams and bung have been removed.
