Mountfield First Time Waste Water Treatment Works

Client:	Southern Water
Location:	Mountfield, Sussex
Value:	£2.8m
Duration:	96 Weeks

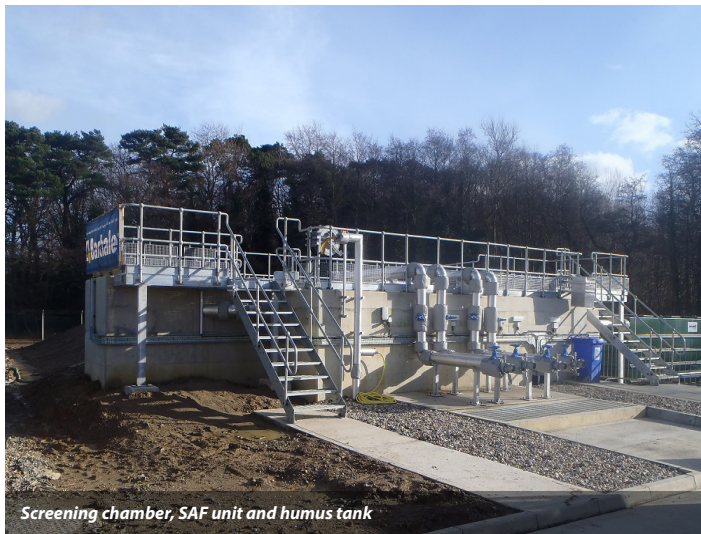
Screening chamber, SAF unit and humus tank

- Above ground SAF tank
- Manhole for the septic tanks and SAF tank drainage
- 5m diameter conical humus tank, complete with air lift auto-desludge, manual operated scum removal and recirculation facilities

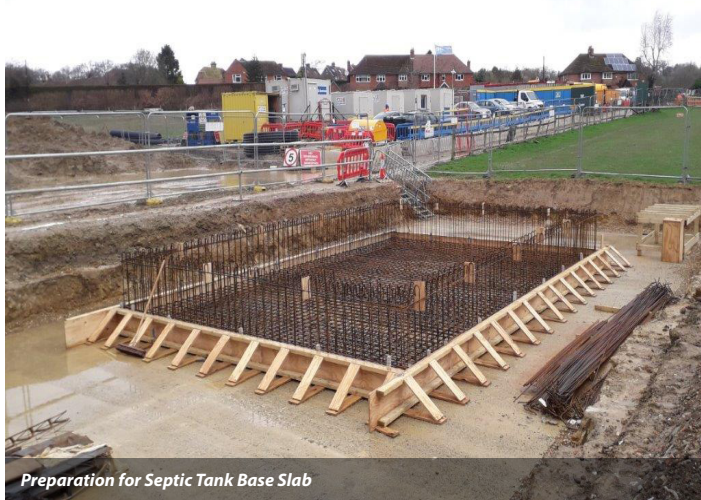
Preparation for Septic Tank Base Slab

- Inlet pumping station (conversion an existing cess tank), and high-level emergency overflow within the inlet pumping station
- 2 no. septic tanks, each with a volume of 36m³, and a sludge collection chamber for the septic tanks

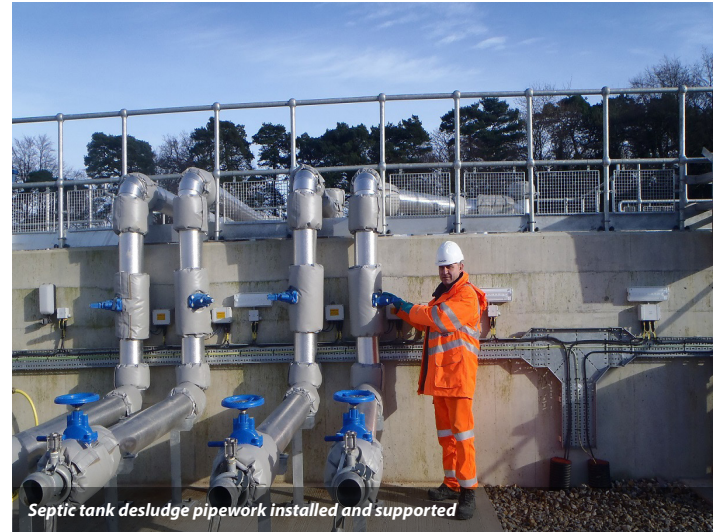
Septic tank desludge pipework installed and supported
