Coltbridge Viaduct

Client: City of Edinburgh Council

Location: West Edinburgh

In Brief...

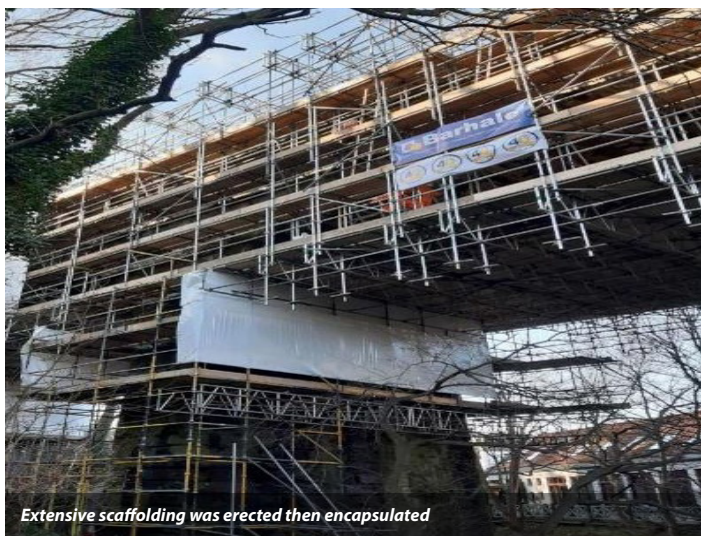
Extensive scaffolding was erected then encapsulated

The first element of works to commence was the installation of extensive scaffolding. A structure was required to provide access to the underside of the viaduct arches.

The subcontractor design required Category 3 checks, and was assembled from the viaduct deck, working over edge of the parapets to suspend the scaffolding for access beneath the arches.

To protect both the workforce and nearby members of the public, the scaffolding was encapsulated. This prevented falling debris and enabled works to continue in storm conditions. This robust method of scaffolding enabled easy access to the works area for both the masonry repairs and regular client visits.

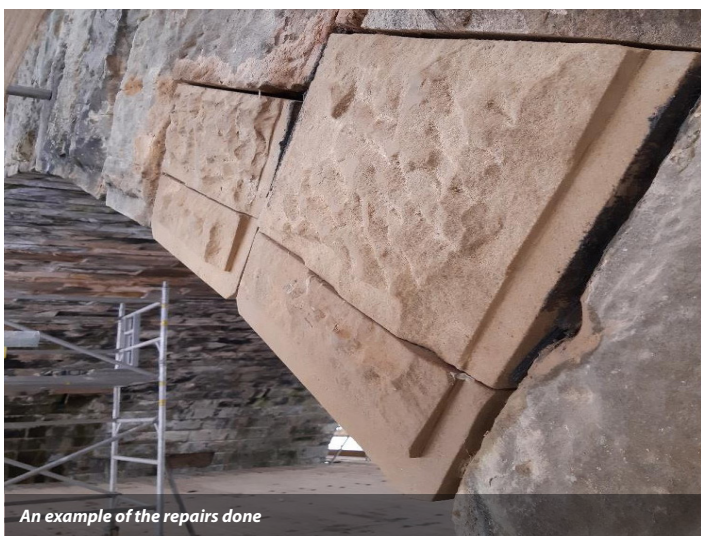
An example of the repairs done

Extensive repairs were required to all three arches. A comprehensive scaffolding/MEWP system was implemented to enable access. The repairs were varied, such as re-pointing mortar in joints that were failing and Lithomix repairs (dressing back, installing repair mortar, finishing with stone repair). All defects were individually identified for each arch and pier.

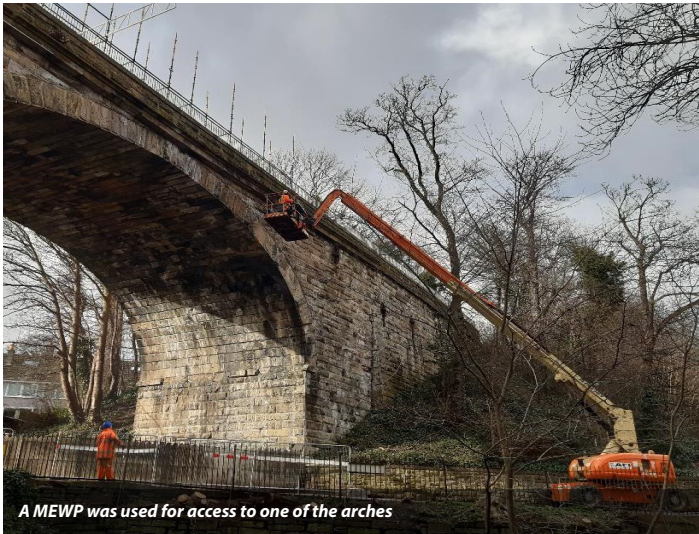
A MEWP was used for access to one of the arches

The original design of the scaffolding had included access for all three arches. However, it was decided that MEWP (Mobile Elevating Work Platform) access would be more efficient, providing a 4 week programme reduction and associated cost savings.

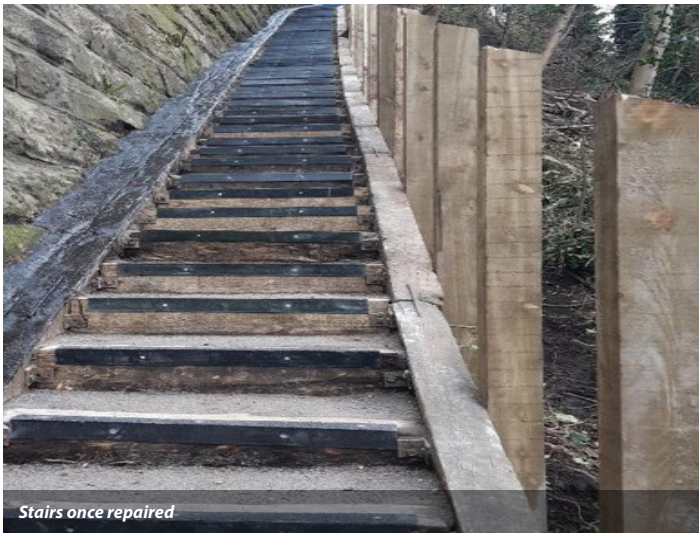
Stairs once repaired

Existing timber stairs from the viaduct to the Water of Leith Walkway were in poor condition so required replacing and re-stoning. The team replaced 50 no. steps and 15 no. posts, along with blasting and painting the hand rail off-site. While reinstating the stoning was only required on 50. no steps, the team decided to do all the steps to fully ensure the safety of users and to improve the overall aesthetic.
