# Battersea to Barrow Hill

**Client:** Thames Water

As part of the AMP7 Tunnels and Aqueducts Programme, Barhale inspected and repaired the 6.8km long Thames Water Ring Main (TWRM) section between Battersea and Barrow Hill. The team replaced or removed pressurised assets on the main, and successfully repaired leaks at over 73 locations, during an outage closely coordinated with Thames Water. The works were completed within budget and programme, and with zero lost time injuries over 3081 man-hours despite the high risk nature of the works.

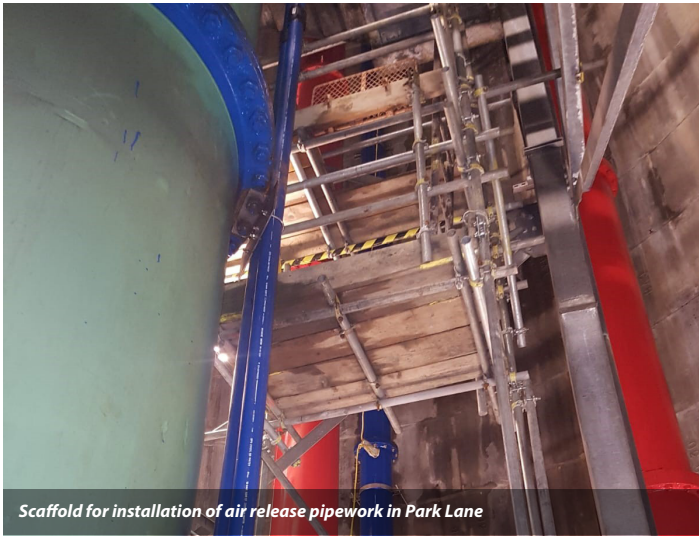
Scaffolding for installation of air release pipework in Park Lane

- Replacement of Flange Adaptors in two locations
- Replacement of Dosing & Sampling Lines
- Removal of Communications Cables
- Repair of Leaking Valve on Bypass Pipework
- NDT on Sump Canister
- Replacement of HIGV Drain Valves in Park Lane Shaft.
- Replacement of the existing Air Release Pipework in Park Lane Shaft
- Replacement of 2 x Gate Valves on the Air Release Pipework in Park Lane Shaft.
- Replacement of 2 x Air Release Valves on the Air Release Pipework in Park Lane Shaft.

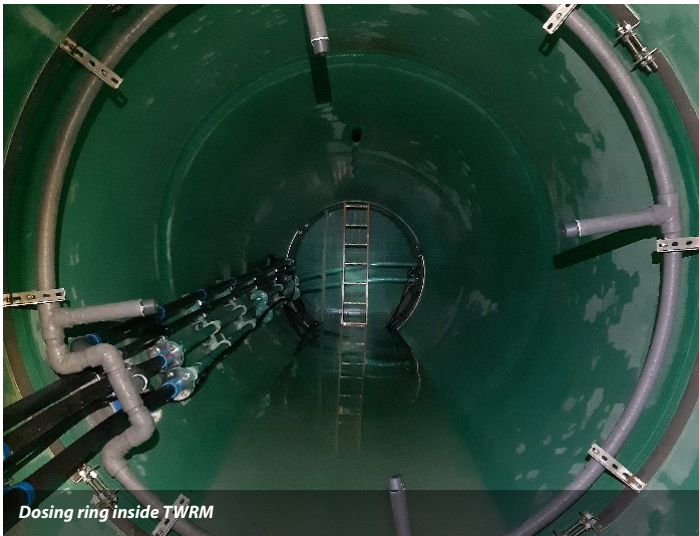
Dosing ring inside TWRM
