# Bescot Footbridge

**Client:** Network Rail

**Location:** Walsall, West Midlands

## In Brief...

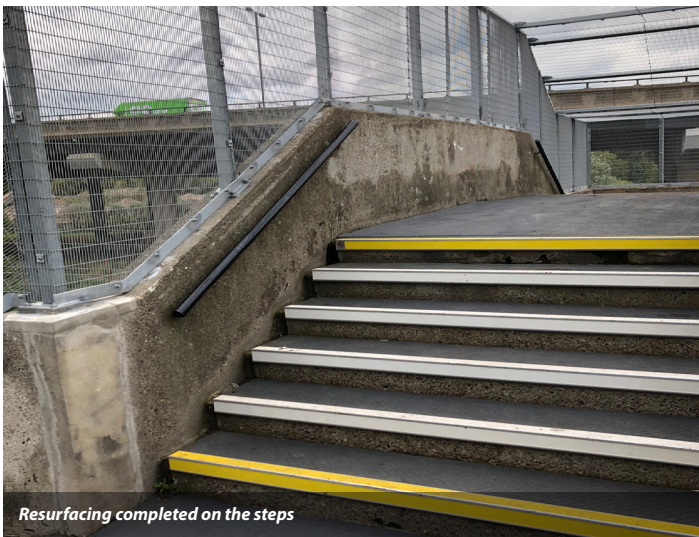
Resurfacing completed on the steps

Structural cracks had been surveyed and assessed by Network Rail's designers and the type of concrete repair specified. These ranged from simple rapid set mortar repairs to break back to reinforcement, pin and concrete re-case. Surfacing and fixing of new nosings were undertaken during normal working hours as the footpath was closed (formally with Walsall and Sandwell Borough Councils) for the duration.

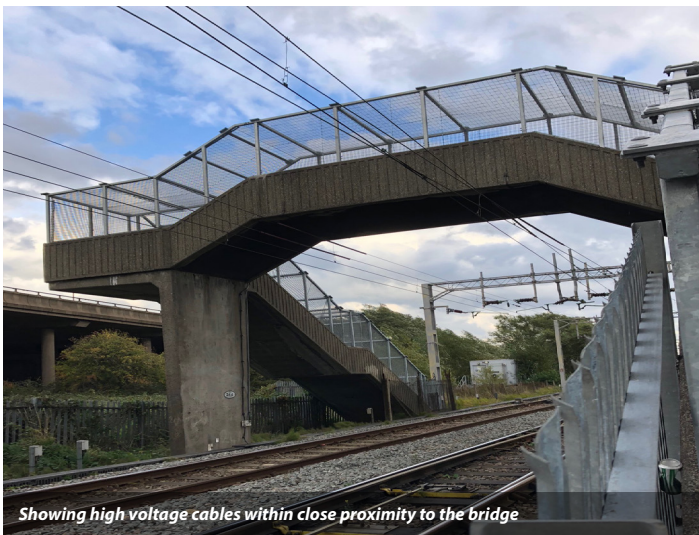
Showing high voltage cables within close proximity to the bridge

- High voltage cables and overhead lines within close proximity to the bridge - isolation required for the majority of the works
- Access to the site was restricted due to the closure of the footpath leading to the bridge
- All materials had to be carried out by hand to the site due to the limited access
- Design modified to be modular to ease assembly on site
- Major signalling and electrification and upgrades were also being undertaken during our contract period, thus meaning we had to interface with multiple contractors for all track side activities, weekly planning meetings were instigated to ensure efficient delivery of works by both parties were met
- Several design issues were identified during the contract, however these were successfully resolved during the fabrication and installation period by BCS Group and Barhale site staff
