Britannia Road - Collapsed Sewer Under Railtrack

Client:	Yorkshire Water
Location:	Huddersfield, South Yorkshire
Value:	£260k
Duration:	4 Months

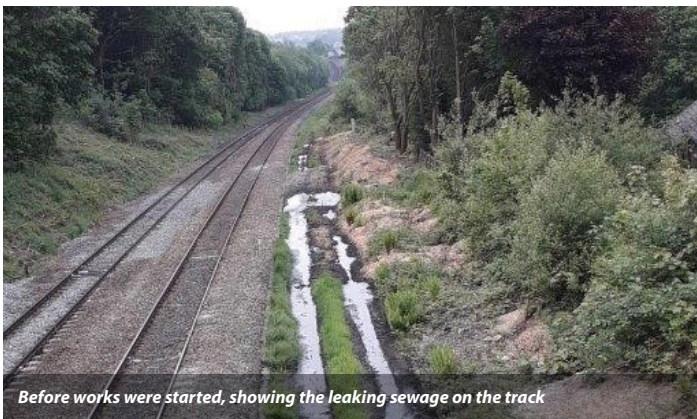
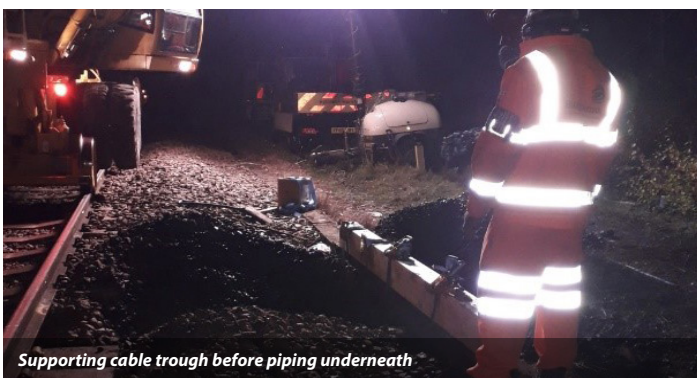
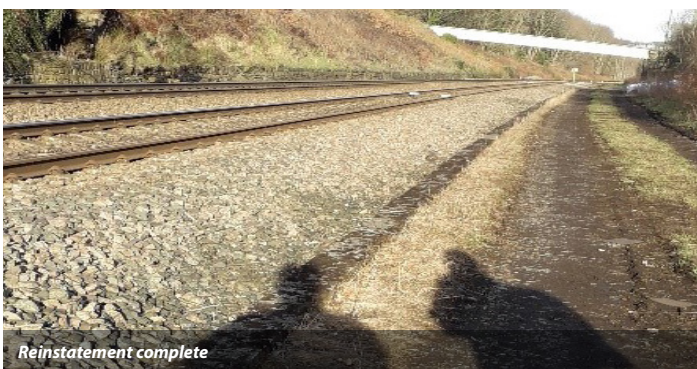
Network Rail informed Yorkshire Water that foul sewage was leaking to the surface and onto the railway track. After CCTV investigation and attempts at unblocking the pipeline, it was found that the 225mm diameter foul sewer had collapsed due to its 100 year old age and ground pressure caused by the trains. The sewer was shallow at only 1.5m depth and had been affected by a Network Rail track drainage project.

Following an optioneering process, the damaged sewer was reinstated at its existing alignment and was relined in sections, with live flows. This required the use of a temporary overpumping system.

- Develop design F001/F002/F003
- Liaise with the ASPRO team
- Temporary works F003 ground support
- Moving sleepers
- Digging down to the sewer
- Excavations were 1-2m in depth
- Removal of collapsed clay sewer which was replaced with a new steel pipeline
- 9.9m of the damaged sewer was replaced with new 250mm diameter pipework

The CCTV investigation works identified some further works that needed to be undertaken. The pipeline had root infiltration, holes and cracks. This was rectified utilising specialist root cutting equipment and GRP internal pipe-lining along a further 18.8m of the pipe.

Once all the works were completed, the sewage contaminated ballast was jet washed down and disinfected to reduce the risk to track workers.
