Ham Island Bridge Refurbishment

Client: eight20 (CABV JV)

Location: Ham Island, Old Windsor

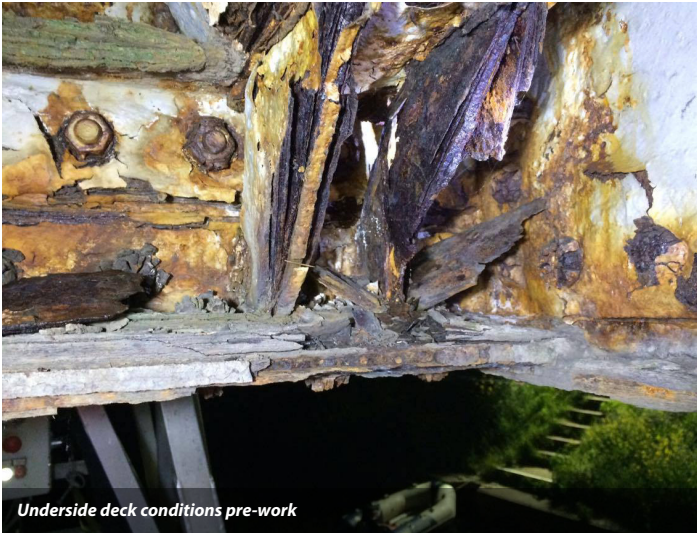
Underside deck conditions pre-work

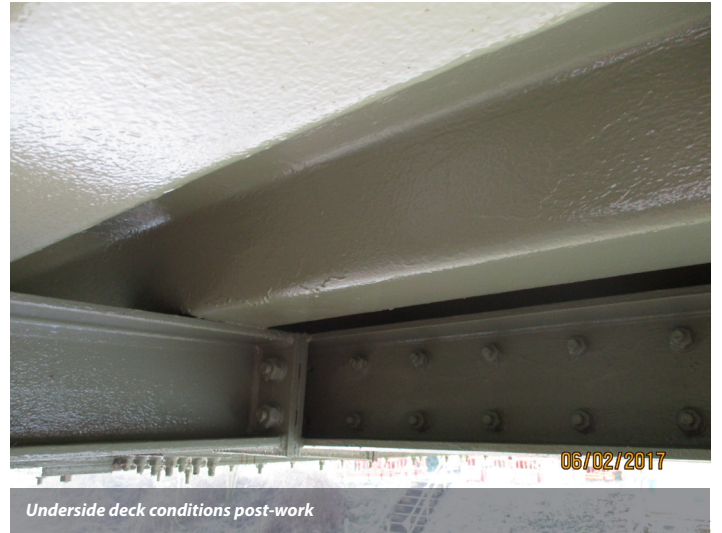
06/02/2017

Underside deck conditions post-work

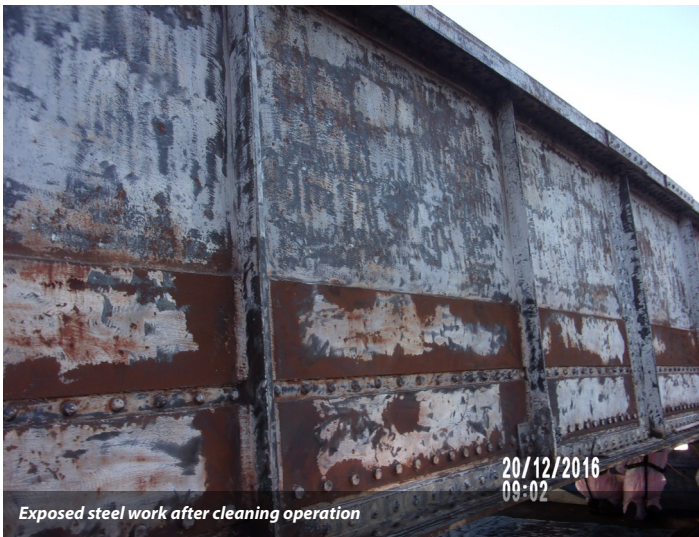
20/12/2016
09:02

Exposed steel work after cleaning operation

- Removal of rust and exposure of all corroded steel. This was carried out using hand tools. All corroded areas had to be prepared to minimum ST2/ST3 standard of EN ISO 8501-1:1998 or equivalent
- Waterproofing and re-surfacing the bridge deck
- Welded installation of steel plates in the bottom flanges of the main edge girders as part of the structural strengthening steelworks
- De-salt washing of the existing bridge surface to reach a soluble salt content of below 4.0ug/cm²
- Application of a waterproof paint system to future proof bridge this included; two coats of rust stabilising glass flake reinforced epoxy primer, followed by two full coats of glass flake reinforced polyurethane finish
