# Kilmarnock Phase 1

**Client:** Scottish Power Energy Networks

**Location:** Kilmarnock, East Ayrshire

Barhale were engaged to provide civils work to facilitate upgrades to the existing Kilmarnock South Substation which could no longer provide sufficient capacity. The existing substation was located to the South of the town of Kilmarnock, East Ayrshire, and consisted of 400/275/132kv compounds. With Phase 1 completed, Phases 2 and 3 are due to take place towards the end of 2018 and through 2019.

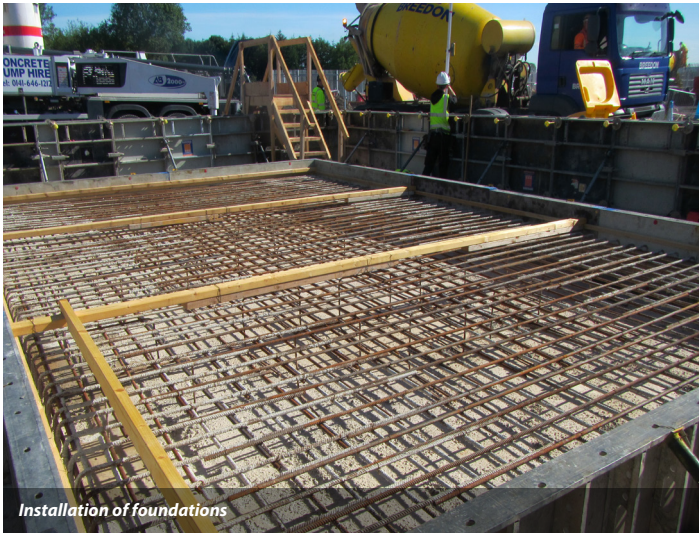
Installation of foundations

Phase 1 of the works consisted of construction and installation of 360 reinforced concrete foundation bases and approximately 2000m of concrete cable trough. These foundations were for a variety of structures such as a new transformer bund and base, GIB structures, breakers, height restriction barriers and new fencing.

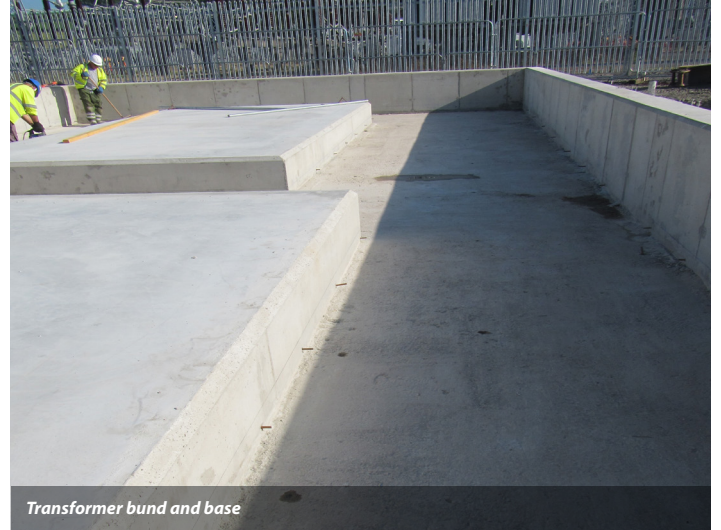
Transformer bund and base

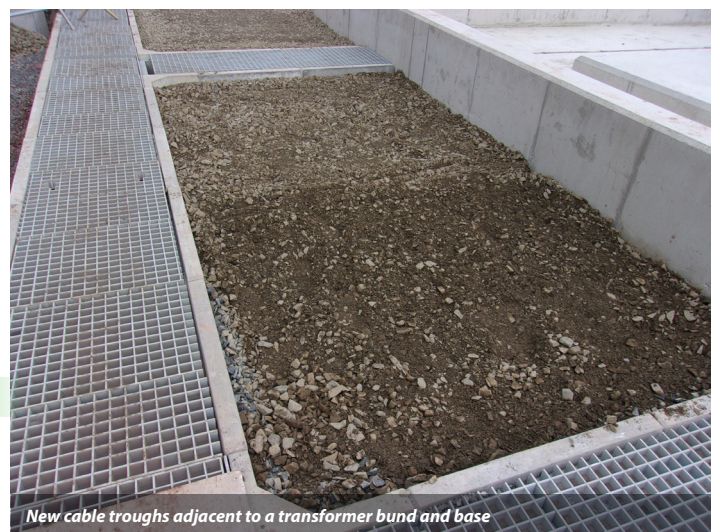
New cable troughs adjacent to a transformer bund and base
