Welcome to HSE Matters, our new style newsletter.

Good practice from around the regions

Learning from around the regions

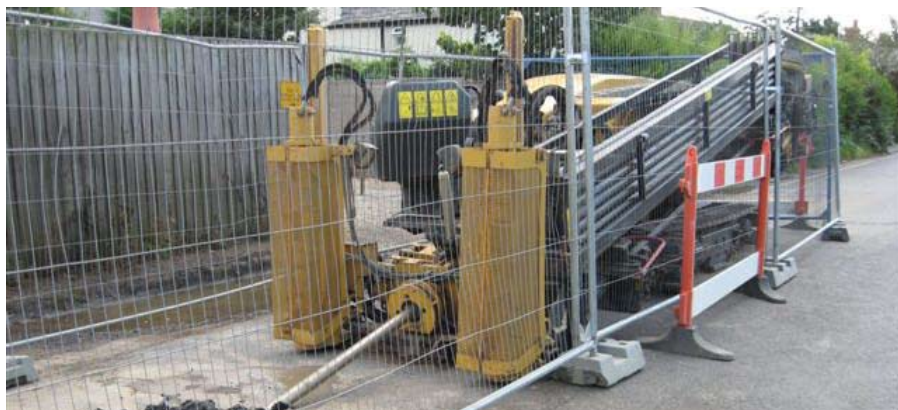
The most at risk stages are the beginning and end (30m or so) of the drill, where the drill passes from ground level through the “service zone” to the pipe invert depth, typically 1.5m deep or more (photo above). Good practice requires us to not just trial hole up to the 1st and last manholes on the run but trial beyond the shot entry and exit points into the ground.

The reamer, an attachment used to expand the hole when pulling the pipes through, must be removed in the last manhole before pulling through to ground level, as the zone of disruption around the reamer is significant, and worsens as depth decreases - posing more of a threat to services. The drill does not actually have to strike the service to cause a strike, as a near miss usually disrupts them sufficiently to cause damage.

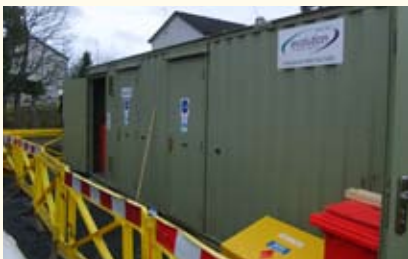
On a Scottish site a bowser and generator has been set up on plant nappies and a travel spill kit attached, this is what we like to see.

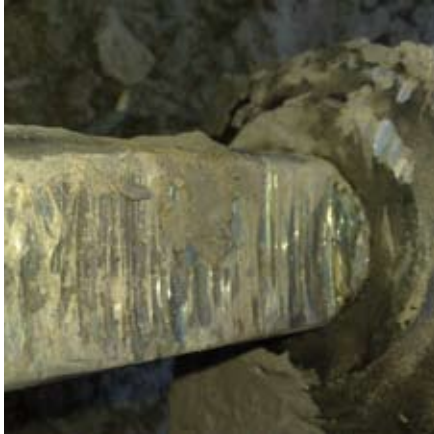
A mounting bracket for a breaker was found to be incompatible with the excavators quick hitch. A visiting engineer decided to grind 10mm off the bracket to 'make it fit'. Spotted by a sharp eyed employee it was removed from use.

- Site Agents / Foremen must ensure visiting plant repair engineers provide a detailed report for the work undertaken, and ensure major modifications are carried out off site.
- There must be confirmation that associated attachments are in line with manufacturer's recommendations, and compatible with the equipment in question.

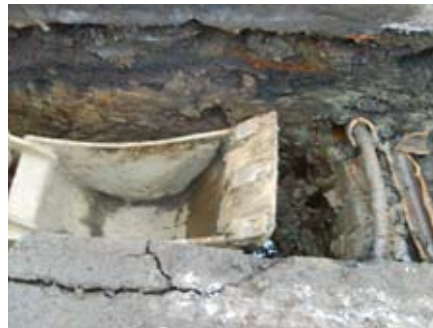
An 11KVA electric cable was struck by an excavator bucket whilst cleaning the bottom of an excavation. Both the operator and banksman failed to anticipate the bucket position in relationship to the exposed cable.

- Banksman must ensure no mechanical plant or equipment enters within 500mm (as a minimum) of any exposed electric cables. Other services may have greater exclusion zones which will be confirmed by the utility owner.
- Site agents must ensure banksman and machine operators are clear about their roles and responsibilities and follow company procedures.
