Yews Lane Bridge Replacement

Client: Network Rail

Location: Cheshire

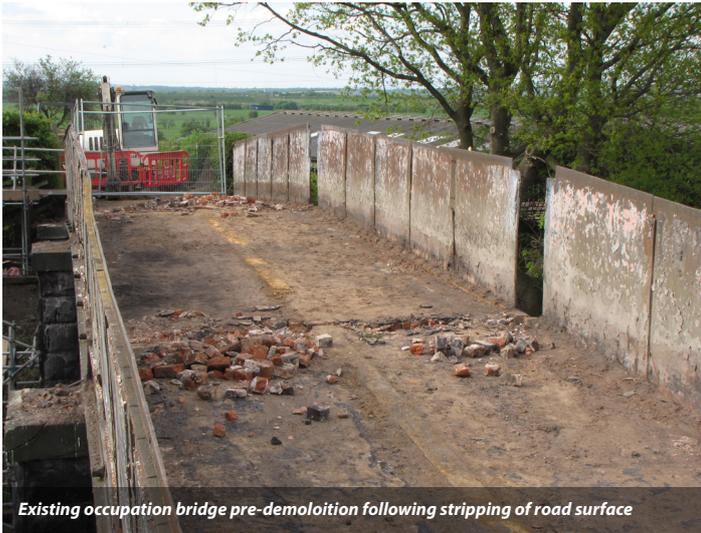
Existing occupation bridge pre-demolition following stripping of road surface

The original bridge deck carried a narrow, rural access track over the railway. Two tracks ran under the central span of the bridge with grassed cutting slopes below the outer spans. The overall span of the bridge was in the region of 32m and the original structure comprised main cast iron girders over the three spans. Masonry jack arches spanned between the main girders, which were supported on masonry abutments and intermediate piers.

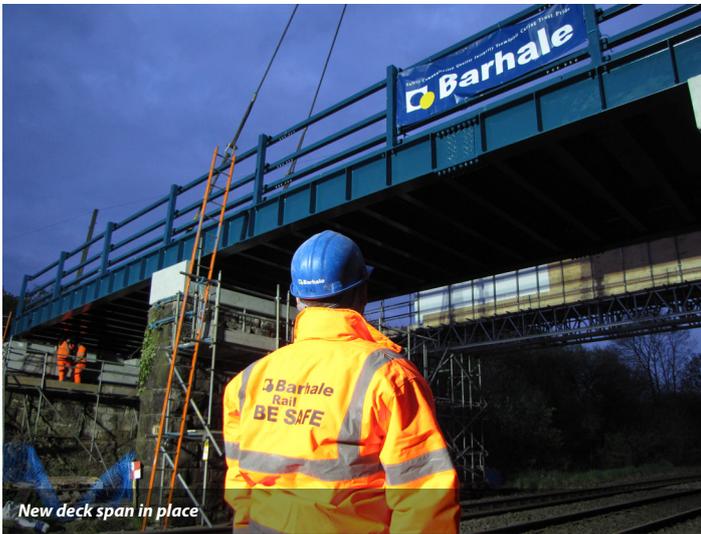
New deck span in place

The bridge was replaced with a new continuous three span bridge supported onto the existing substructure and fabricated using open steel sections. New precast concrete cill beams formed part of the design at both abutments and at the two piers. The replacement bridge was fabricated, assembled and tested within a workshop facility by our BCS team and a trial lift was carried out within the workshop prior to stripping and shipping to the painters. This gave the team confidence that the structure was dimensionally correct and it allowed the lifting frame attachments to be checked and trimmed.

The fully painted deck span was delivered to site in small sections and assembled within the compound area adjacent to the crane position and the deck waterproofing applied. The total weight of the completed structure, including parapet units and bearing units totalled 60 tonnes, the decision to lift such a heavy span in one unit, was driven by the relatively short possession regime available.

The demolition and installation of the new replacement bridge was undertaken during a 54 hour OROR possession. A 1,000 tonne mobile crane was set up in the adjacent compound area, this was used to lift out the original bridge structure and then lift the 4 No PCC cill units and the new deck span into position.
