INTU Lakeside Enabling Works

Client: INTU Lakeside Limited

Location: Grays, Essex

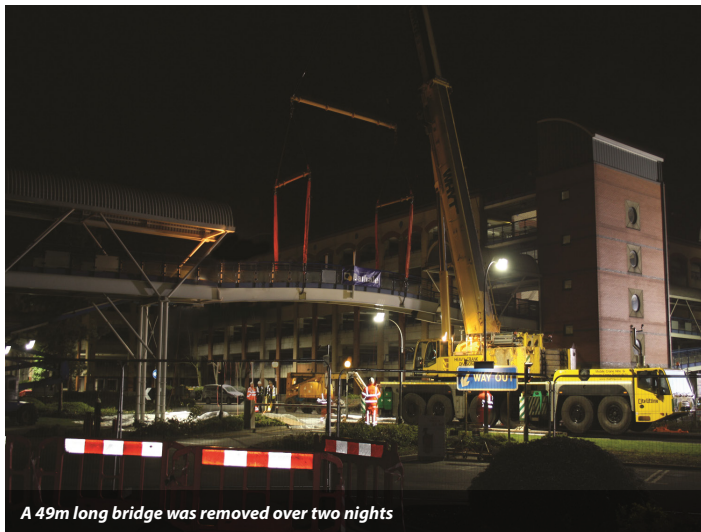
A 49m long bridge was removed over two nights

The bridge spanned a distance of 49m and was removed over a period of two nights. Demolition works were carried out by Barhale's competent subcontractor, Squibb Group. The bridge deck was cut into four sections by trained welders using burning tools. After each section had been cut, they were individually lifted out of place by a 350t crane supplied by City Lifting Ltd. All demolition works were carried out at night to allow the team unrestricted access to the bridge location, without the risk of disrupting shoppers visiting the centre. This meant the team had to work to extremely tight deadlines to ensure the demolition was carried out within the allotted time frame.

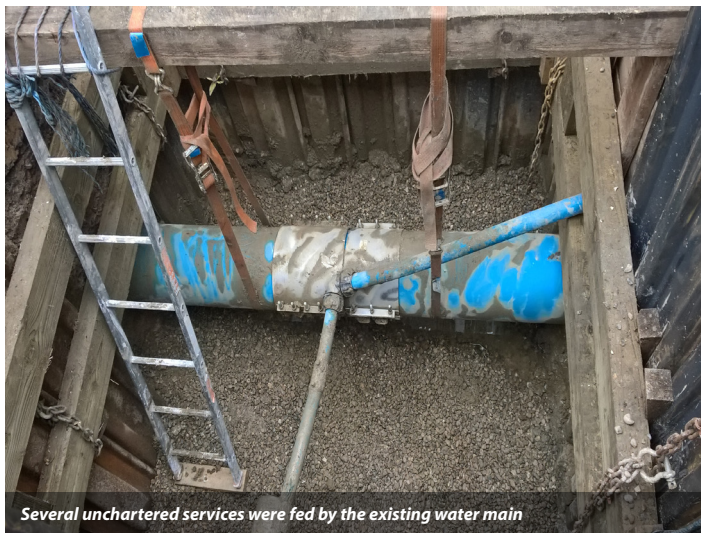
Several uncharted services were fed by the existing water main

During the excavation operations, the Barhale team uncovered 19 uncharted water services leading into the shopping centre, which were fed by the existing water ring main. Neither Essex and Suffolk Water nor INTU were certain of the status of the services. The Barhale team therefore carried out tests on all services to ensure no areas within the centre were left without water. The team found five of the services to be live and 14 to be dead.

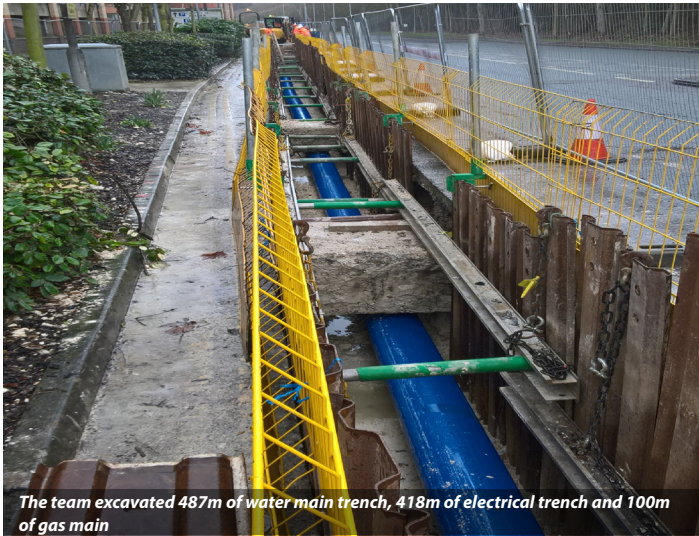
The team excavated 487m of water main trench, 418m of electrical trench and 100m of gas main

- 487m of 355mm water main
- 418m of HV ducting
- 100m of 63mm gas main

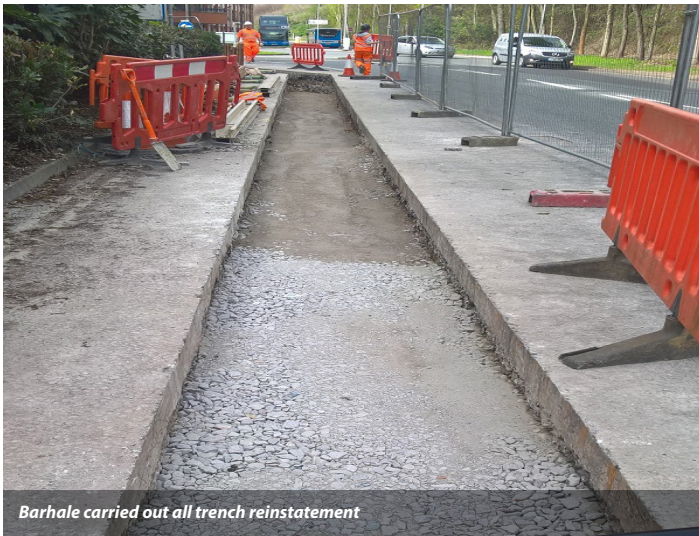
Barhale carried out all trench reinstatement

The Barhale team excavated diversionary trenches through open cut techniques into which the new services were installed by third party stakeholders. Barhale then carried out all backfilling and reinstatement operations, including bitumen surfacing and paving stone laying.
